Manhole Inspection Summary

Manhole # S61U__008MH

Insp Date: **8/31/09 11:00 AM**

Location Address: **HOLABIRD AVE.**

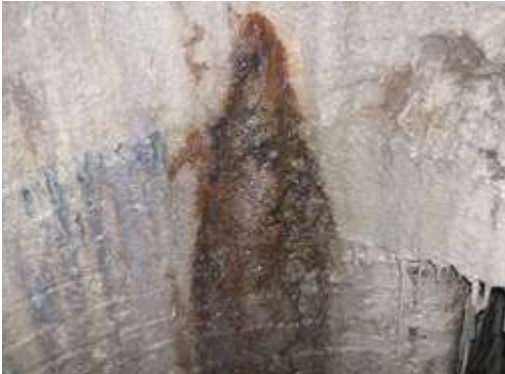
Defect 2

Condition: ☐ Sound ☐ Cracked ☐ Root Intrusion ☐ Loose Brick ☒ **Deteriorated**

Infiltration: ☐ None ☐ Joint ☒ **Cracks** ☒ **Mortar** ☐ Roots ☒ **Wall**

INFILTRATION ON BARREL NEAR BENCH

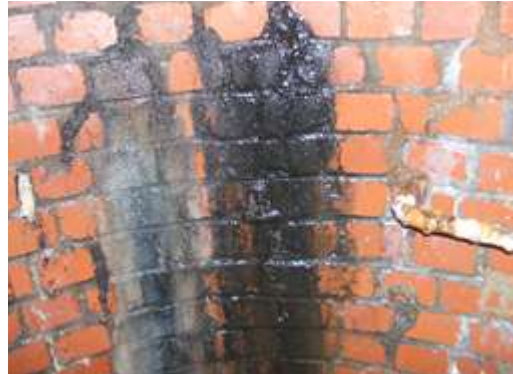
Defect 1

INFILTRATION ON BARREL WALL

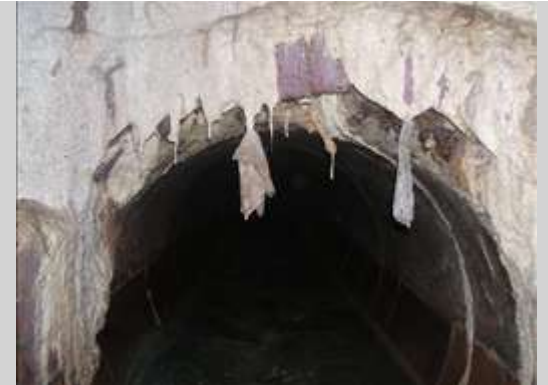
12 O'Clock Outflow

30 in. Circular Gravity Sewer
Pipe Out @ 12 O'Clock

Pipe Height: (in.) Direct
Pipe Material: **Clay** ☐ Pipe Lined
Invert Depth: **21.97** (ft.) Flow Characteristics: **Slow**
Deposits: ☐ None ☐ Mud ☐ ~~Gravy~~ ☒ **Debris** ☐ Grease
Silt Depth: **0.5** (in.) Deposits Extent: **Light**
Infiltration: **None** Pipe Seal Cond: **Sound**

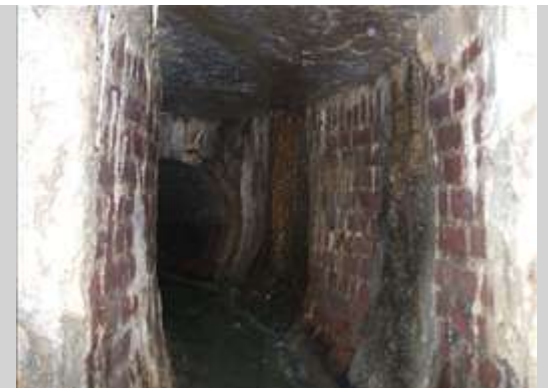
4 O'Clock Inflow

30 in. Circular Gravity Sewer
Pipe In @ 4 O'Clock

Pipe Height: (in.) Direct
Pipe Material: **Clay** ☐ Pipe Lined
Invert Depth: **21.74** (ft.) Flow Characteristics: **Slow**
Deposits: ☐ None ☐ Mud ☒ ~~Gravy~~ ☐ Debris ☐ Grease
Silt Depth: **0.5** (in.) Deposits Extent: **Light**
Infiltration: **None** Pipe Seal Cond: **Sound**
